Manhole Inspection Summary

Manhole # S11O__028MH

Insp Date: **4/16/08 1:50 PM**

Location Address: **3220 Frederick Ave**

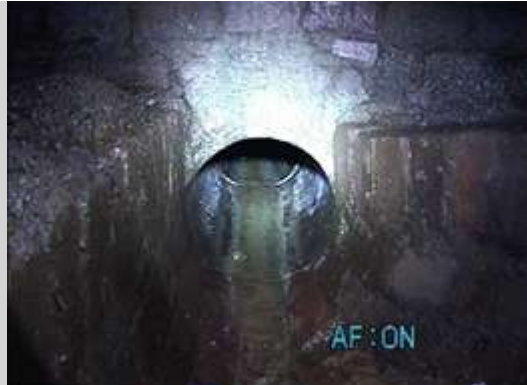
12 O'Clock Outflow

8 in. Circular Gravity Sewer
Pipe Out @ 12 O'Clock

Pipe Height: **8.4** (in.) Rod and Bar (Angled)
Pipe Material: **Clay** ☐ Pipe Lined
Invert Depth: **12.17** (ft.) Flow Characteristics: **Fast**
Deposits: ☒ None ☐ Mud ☐ Sludge ☐ Debris ☐ Grease
Silt Depth: **0** (in.) Deposits Extent:
Infiltration: **None** Pipe Seal Cond: **Sound**

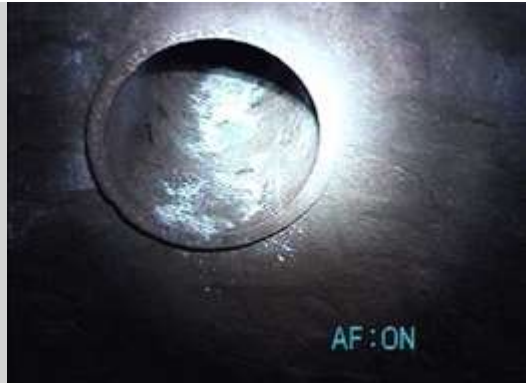
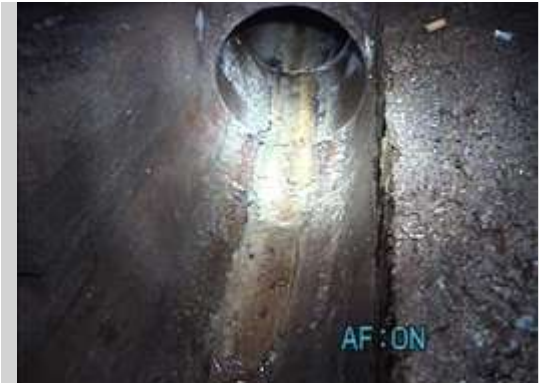
6 O'Clock Inflow

Pipe In @ 6 O'Clock

Drop In @ 6 O'Clock

Pipe Height: **8.4** (in.) Rod and Bar (Angled)

Infiltration: **None** Pipe Seal Cond: **Sound**

Drop Condition: **Open**
